ADDENDUM NO. 2

JFSB 2024 CNA Remodel Office Suites 1041 & 1053

AN ASBESTOS SURVEY AND ASSESSMENT FOR

**BYU
Joseph F. Smith Building
1100 Campus Drive
Provo, Utah, 84604
March 12, 2024**

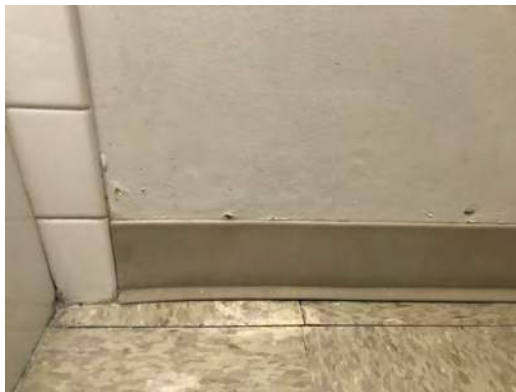
Vinyl Tile			
-------------------	--	--	--

JFSB-3724-8	12"x12" Tan Vinyl Tile/None Detected	1,500 sf	Custodial, Basement Labs
JFSB-3724-30	12"x12" Tan Vinyl Tile/None Detected	1,500 sf	Custodial, Basement Labs
JFSB-3724-35	12"x12" Tan Vinyl Tile/None Detected	1,500 sf	Custodial, Basement Labs

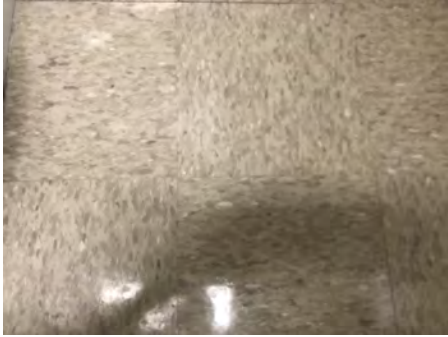
JFSB-3724-27	2'x2' Beige Vinyl Tile/None Detected	200 sf	Stairwells
JFSB-3724-28	2'x2' Beige Vinyl Tile/None Detected	200 sf	Stairwells
