**GEOTECHNICAL INVESTIGATION  
TOOELE TENTH AND MAIN DEVELOPMENT  
1000 NORTH SR-36  
TOOELE, UTAH**

**PROJECT NO. 1180597**

**MARCH 4, 2019**

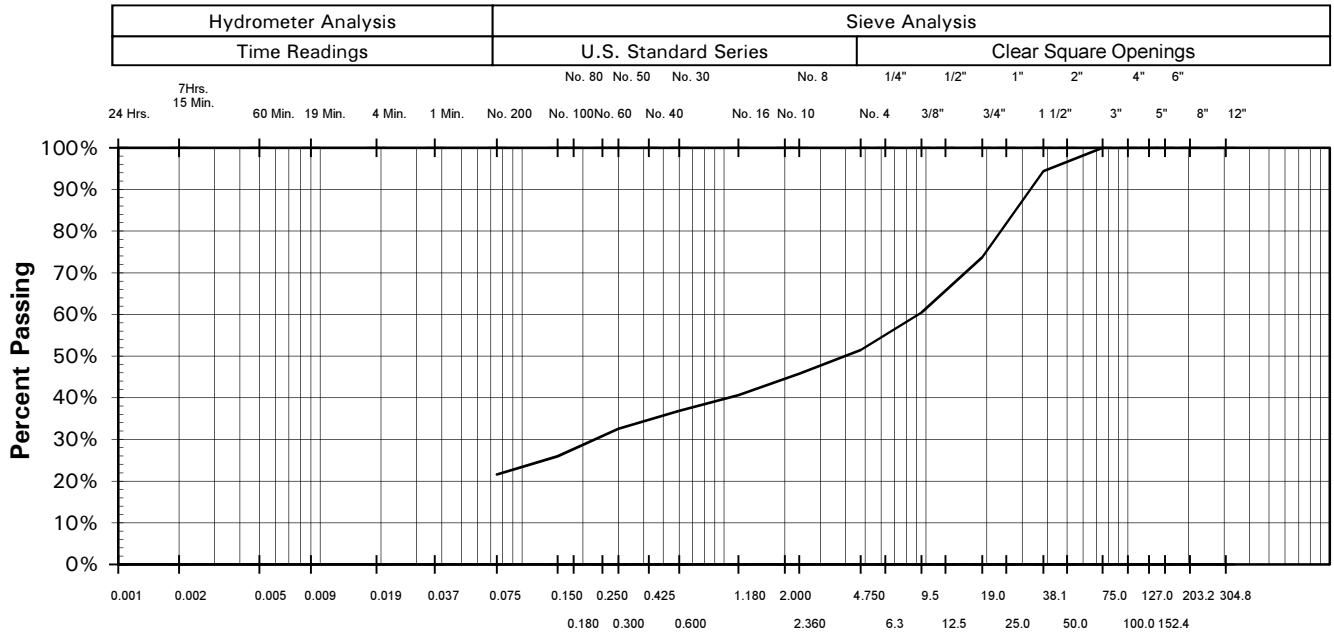
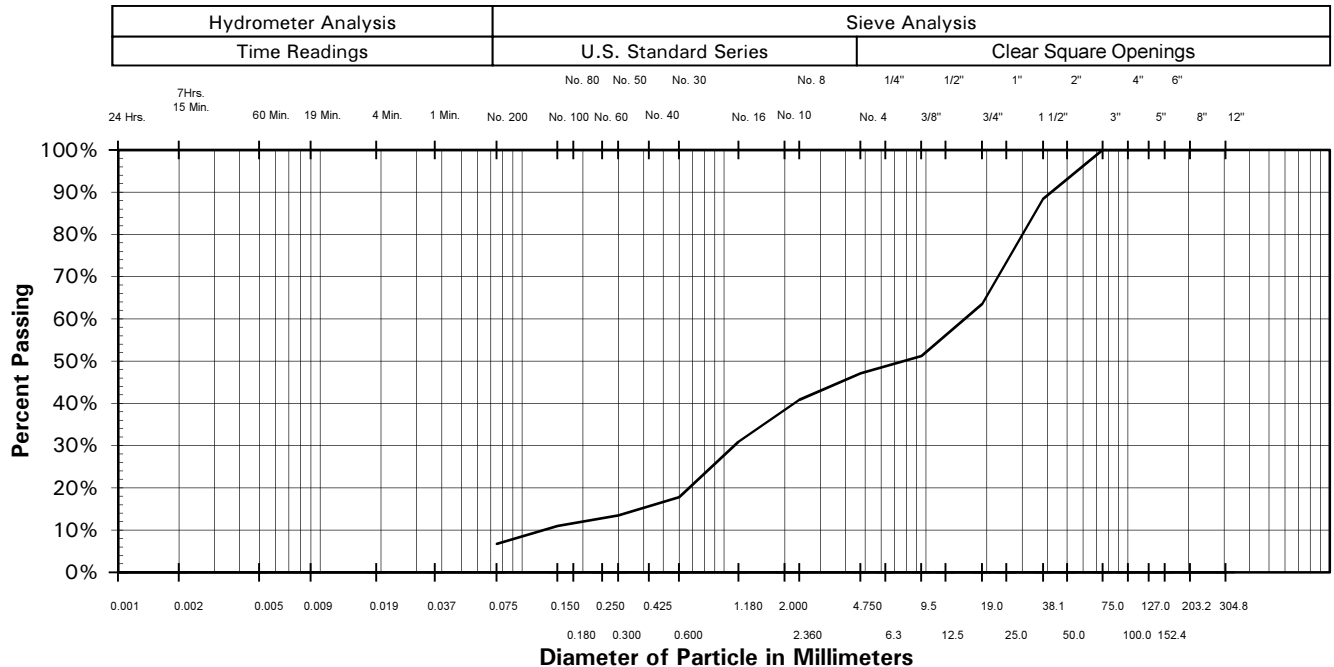
Laboratory tests conducted on a sample of the fill indicate a moisture content of 4 percent. The results of a gradation test conducted on a sample of the fill are presented on Figure 7.

The results of laboratory tests conducted on a sample of the gravel indicate a natural moisture content of 4 percent. The results of a gradation test conducted on a sample of the gravel are presented on Figure 7.
