**GEOTECHNICAL INVESTIGATION  
PROPOSED FIELDHOUSE  
CORNER CANYON HIGH SCHOOL  
12943 SOUTH 700 EAST  
DRAPER, UTAH**

**PROJECT NO. 1240393**

**JULY 30, 2024**

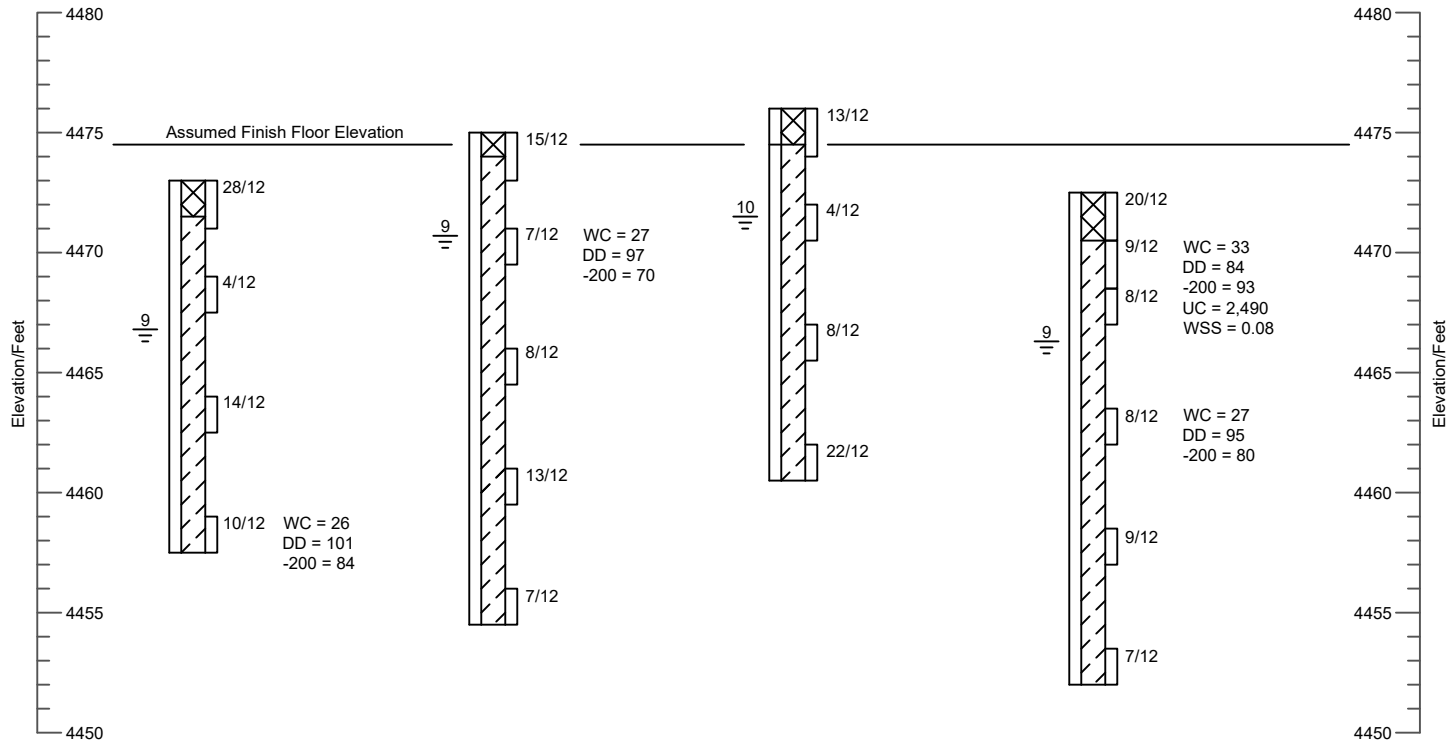
B-1  
Elev. 4473'

B-3  
Elev. 4476'

B-4  
Elev. 4472½'

Approximate Vertical Scale 1" = 8'

See Figure 4 for Legend and Notes

The field study was conducted on July 3, 8 and 9, 2024. Ten borings were drilled at the approximate locations indicated on Figure 1 using direct push for Borings B-7 and B-10 and 8-inch-diameter hollow-stem auger for the other borings. The borings were logged and soil samples obtained by representatives of AGECE. Logs of the subsurface conditions encountered in the borings are graphically shown on Figures 2 and 3 with legend and notes on Figure 4.
